OPTIONS APPRAISAL FOR THE PROVISION
OF FACILITIES
AT
ALL SAINTS CHURCH
THE HILL, LANGPORT
TA10 9QF

Project Ref HBA 383
Client The Churches Conservation Trust
Date of Issue 28th March 2024

The purpose of this document is to explore options for the provision of facilities at All Saints Church Langport to support its potential use by the local community as a concert venue.

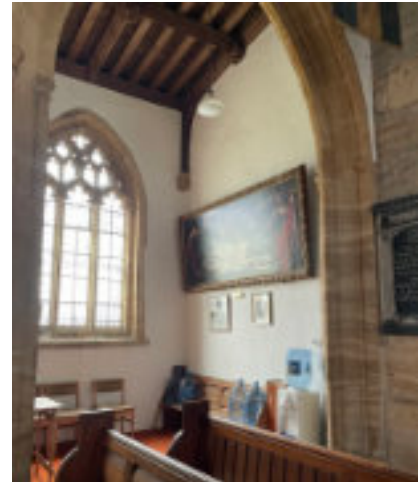
Fig.9 West end of South Aisle

This is a space at the rear of the church where the pews have been removed. Although it is close to the mains water supply drainage from this location depends on the drain run below the church being in good condition.

It would be quite difficult to create a large enough enclosure here without significantly disrupting the visual symmetry of the nave and blocking south light.

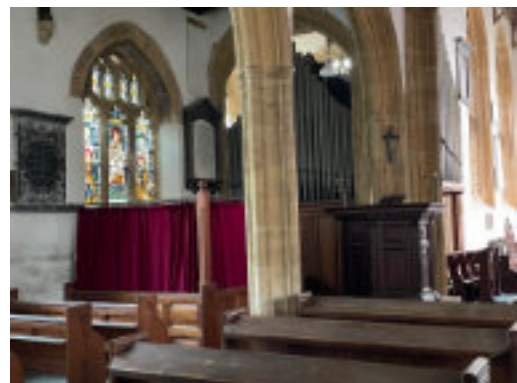
Fig.10 The East end of the North Aisle

At the east end of north aisle there is an area partitioned off with a curtain behind the pulpit.

Whilst a connection to the mains sewer might be easier to achieve here there is not really sufficient space to provide facilities that would justify the difficulty (and expense) taking into account the need to access the transept staircase and north transept.

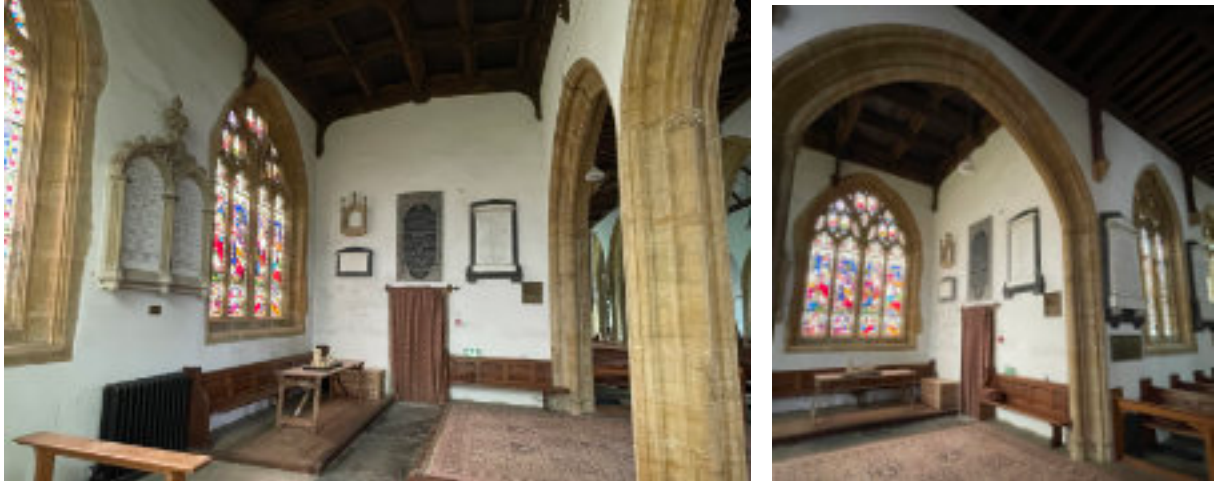
Fig.11 The South Chapel

This is a large open space with a separate external door and large stained glass windows on all but the western wall. An enclosed WC in this location would compromise the use of this space and obscure at least one large stained glass window and is therefore very unlikely to be acceptable to either the Churches Conservation Trust or the Conservation Officer.

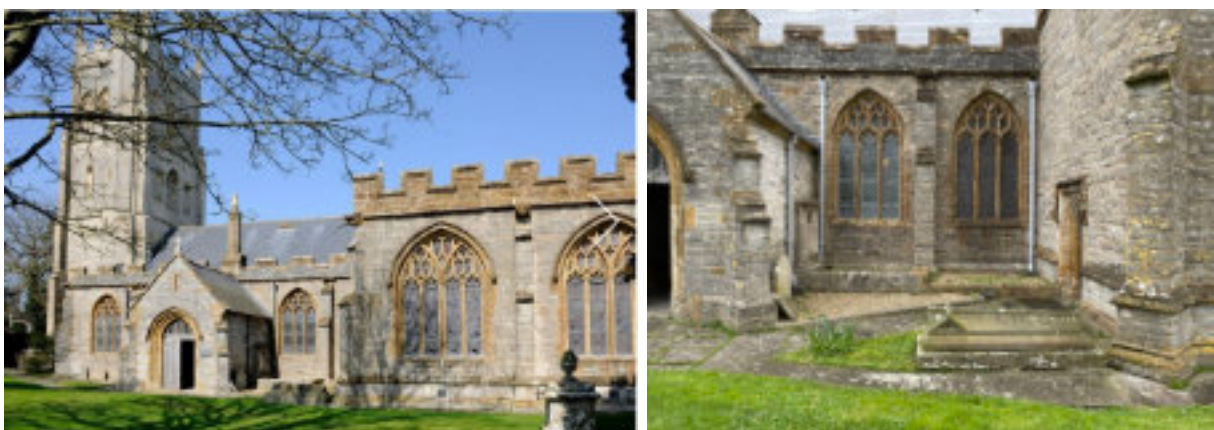
Fig.12 View from South Churchyard

The option for an external 'extension' against an outside wall has been explored with the most suitable candidate being between the south chapel and the south porch with access from the south chapel doorway. However this location would have a significant visual impact on the appearance of the church from the churchyard. It would require some memorials to be re-located and would block south light from the church.

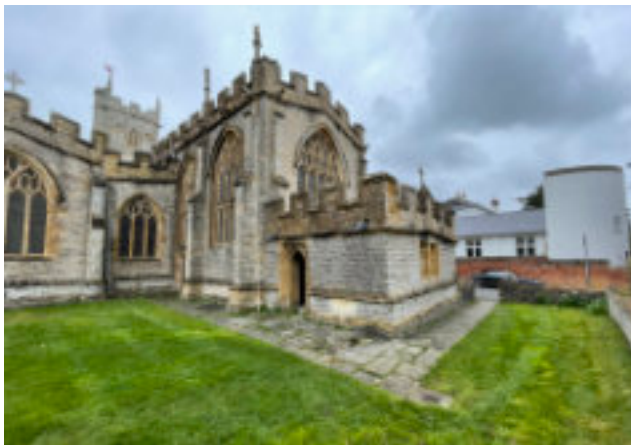
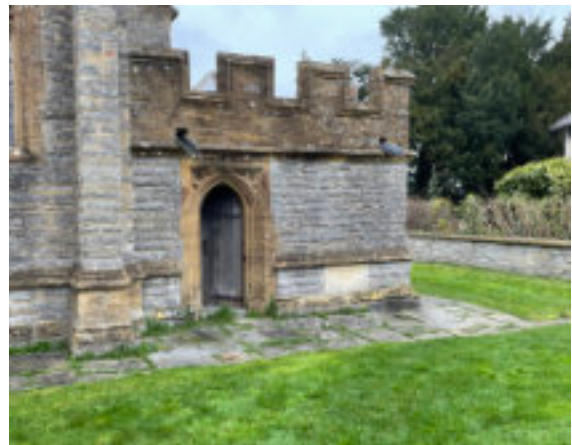
Fig.13 The Vestry exterior

The vestry, located at the east end of the chancel offers the most potential for accommodating WC facilities. This location would have no visual impact on the interior or exterior of the church and is therefore unlikely to be contentious from the point of view of Listed Building Consent. This part of the building is reported to have been 'in ruins' in 1785 and re-built in 1822 and is therefore the least sensitive part of the building from the point of view of historic fabric.

The space is currently used for storage and can be accessed directly from the churchyard (level access) or from the chancel (stepped access).

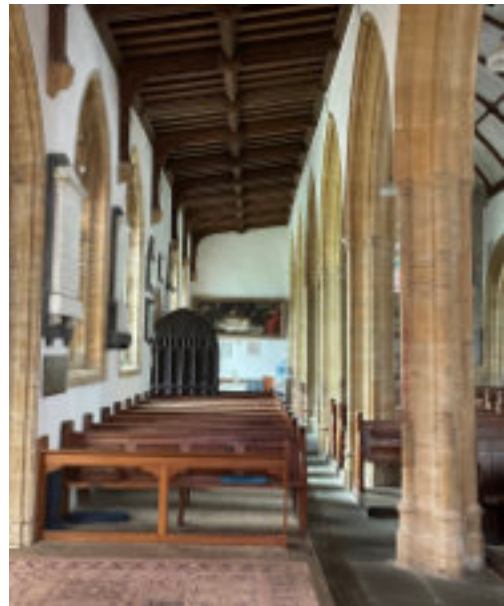
Fig.16 proposed location of kitchenette cabinet in the South Aisle

Alongside the provision of WC facilities it would be beneficial to be able to provide some basic catering facilities comprising a place to locate tea urns, a cold water tap and sink and a serving space.

This could be relatively easily achieved with the provision of fixed storage cabinet and worktop at the west end of the south aisle as indicated below.

It would be beneficial to remove the raised timber pew base to avoid a trip hazard in this area as part of the work to run services to the new fixed cabinet.
